**- INSPECTION REPORT
NATIONAL DAM SAFETY PROGRAM**

**HACKER DAM
MADISON COUNTY, MONTANA
MT - 1276**

January 1981

Subject: Hacker Dam (MT-1276) Field Inspection

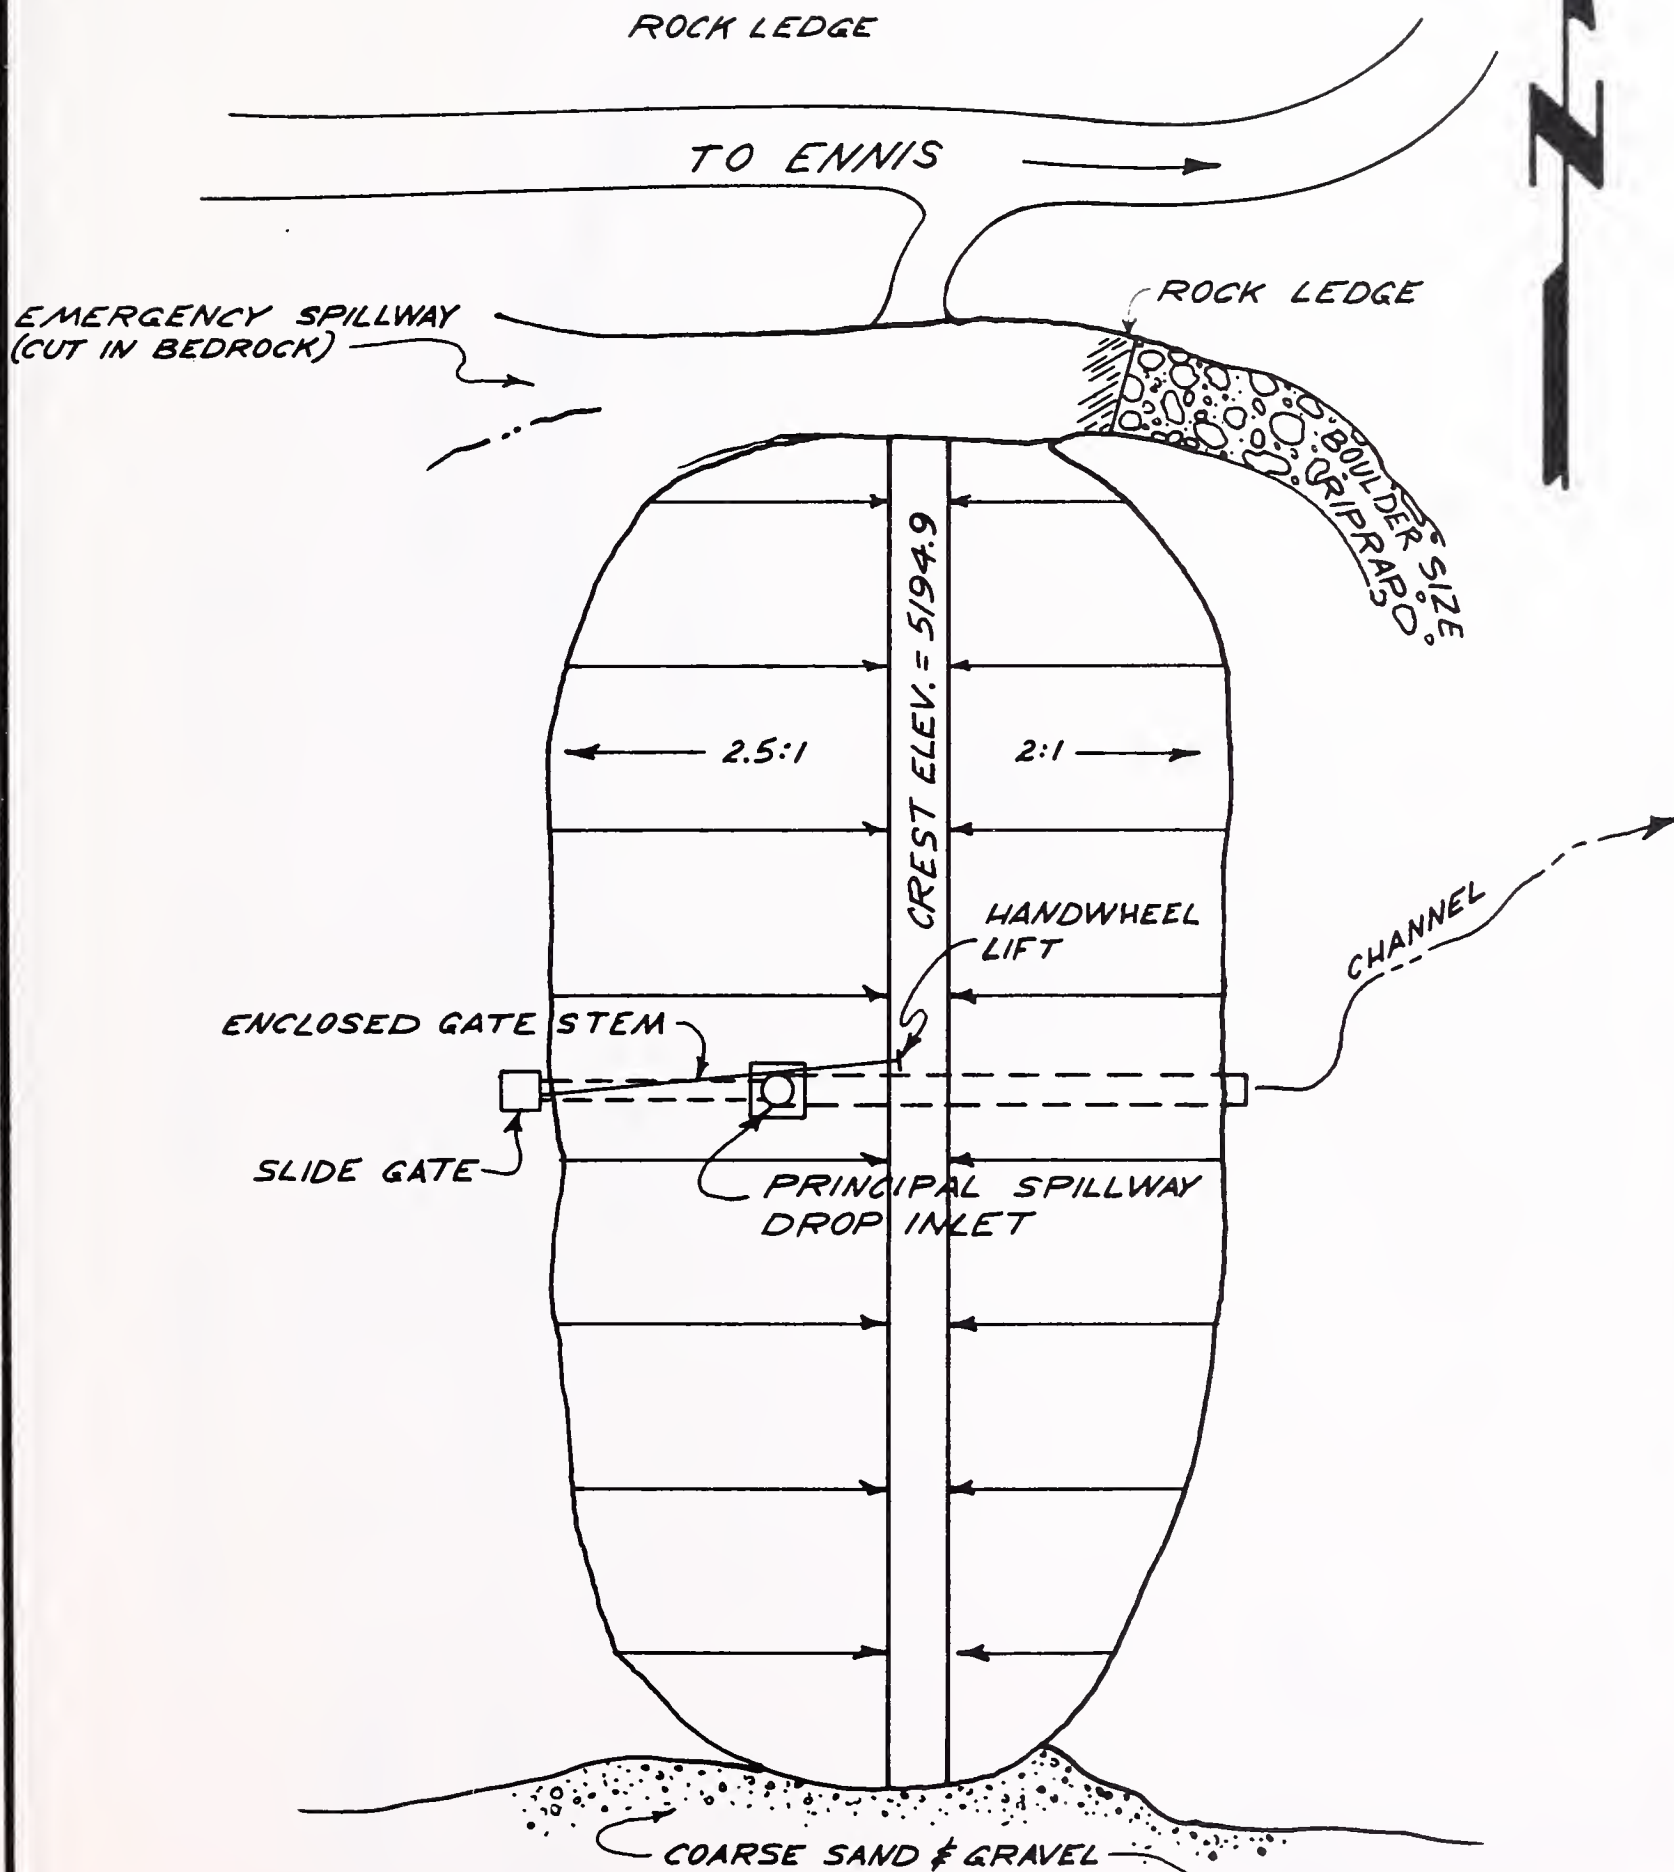
PLATE 3
HACKER DAM
SITE PLAN

The dam has been constructed in a narrow valley, formed by down cutting of Moores Creek through the cobble and gravel terrace deposits. (Photo 1) Down-cutting proceeded until Precambrian bedrock was encountered at the left abutment (Photo 2 - background). The creek subsequently began to follow this bedrock contact; the valley then begins to fan and widen out just downstream from the dam. The dam abuts two different types of material. The left abutment is Precambrian gneiss, schists, and quartzite. These rocks are very decomposed and weathered. The rocks strike approximately parallel to the dam and dip downstream at about 70°. The quartzite beds form distinctive units that are approximately 6 inches to 2 feet thick and are interbedded throughout the exposure. The right abutment of the dam is a heterogeneous deposit of Pleistocene cobbles and coarse sand and gravel. (Plate 3)
